3D Reconstruction of a Precast Concrete Bridge for Damage Inspection Using Images from Low-Cost Unmanned Aerial Vehicle

The bridge selected for this study was a concrete bridge at Gada-Biu along Kwakonka-Tudun Wada Road, Jos, Plateau state, North central, Nigeria. The bridge as shown in Figure 3 consist of 3No span, each 18m long, with a total length of 54m. The superstructure consists of 8 precast T-beams on each span of the twin bridge. The carriageway is 6m with a precast parapet wall on both sides. The substructure consists of 2 piers connected by a pier cap at 4 different locations. The abutment, which is of the bank seat type, occupies the extremities of the flyover. The bridge was constructed in 2010 and has an estimated annual average daily traffic (AADT) of 5,000.

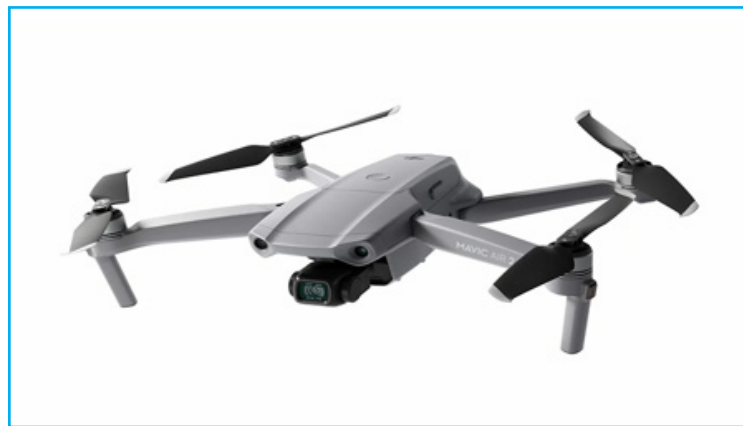
Figure 1. DJI Mavic Air 2 UAV drone

The DJI Mavic Air 2 UAV drone (Figures 1 and 2) paired with the high-resolution 48-megapixel digital camera and 4K video resolution was used for the study (Table 2). This is essential due to its exceptional combination of accuracy, stability, and image quality.

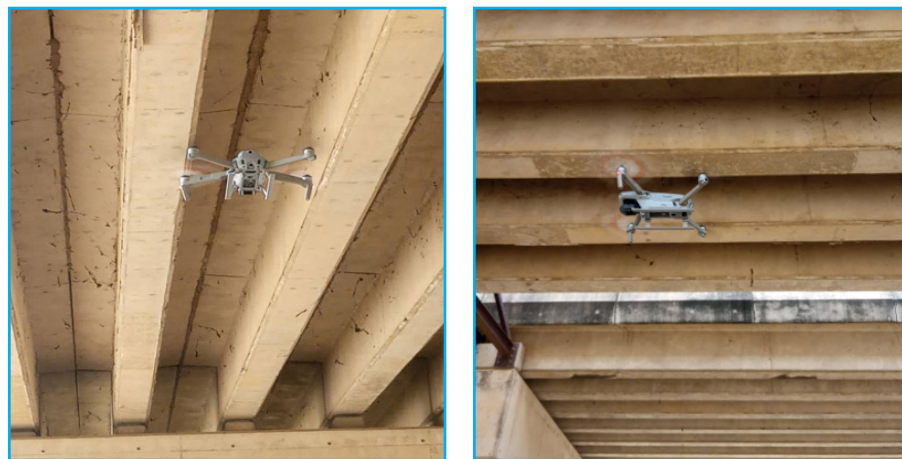
Figure 2. DJI Mavic Air 2 UAV drone during image acquisition

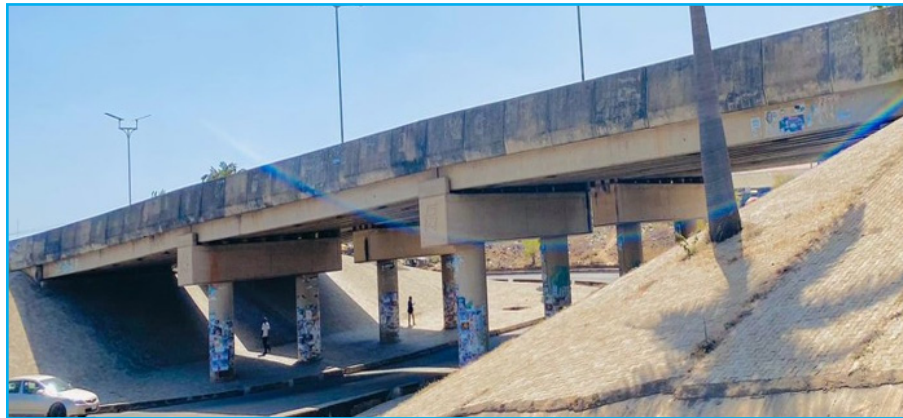
Figure 3. Real image of the bridge

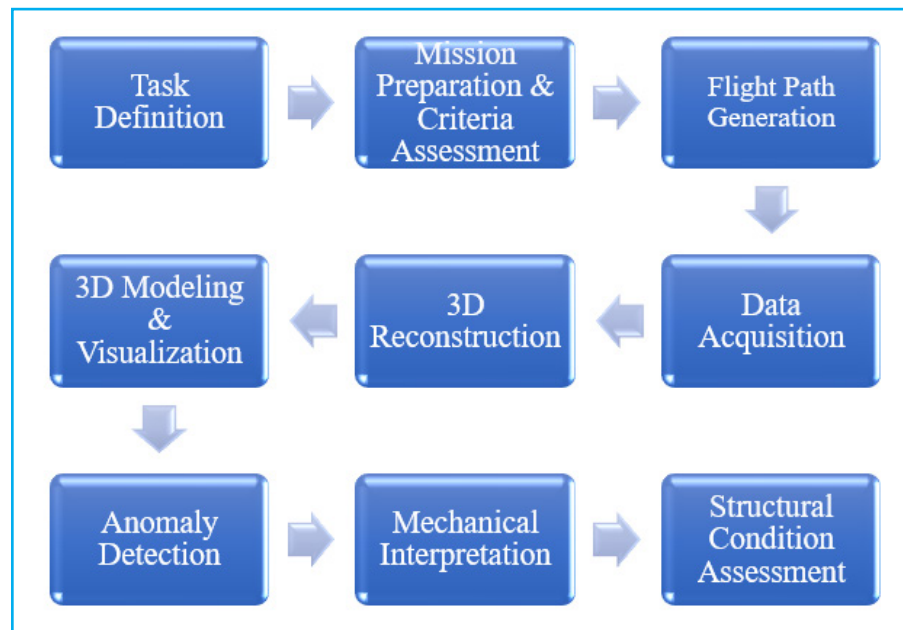
Figure 5. 3A detailed methodology for UAV-based damage inspection & condition assessment

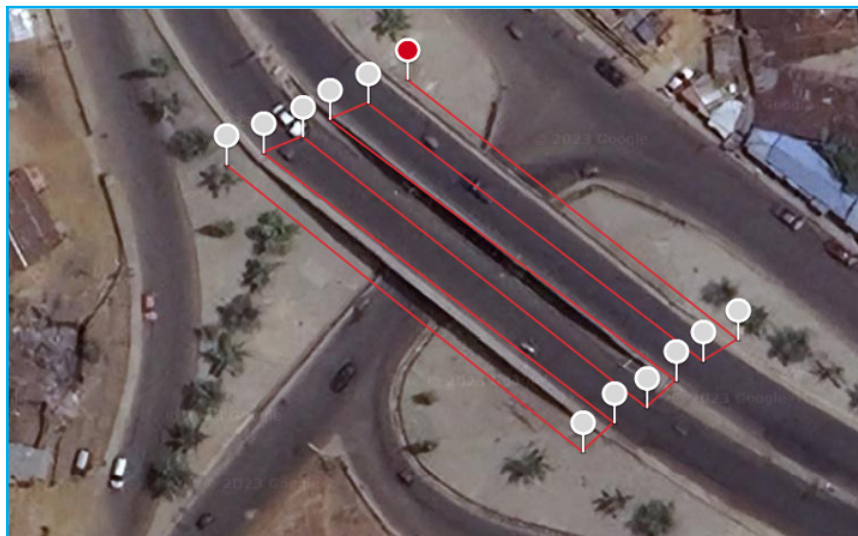
Figure 7. Mapping path for super-structure

DJI Fly software is utilized to control and manually generate flight paths for the UAS. Flight paths were designed to cover the entire bridge infrastructure, ensuring proper overlap between images to facilitate accurate 3D reconstruction. The mapping paths for the sub-structure and super-structure are as shown in Figure 6 and Figures 7 respectively. These are a straight-line trajectories and flights routes on the bridge at different heights and camera inclinations.

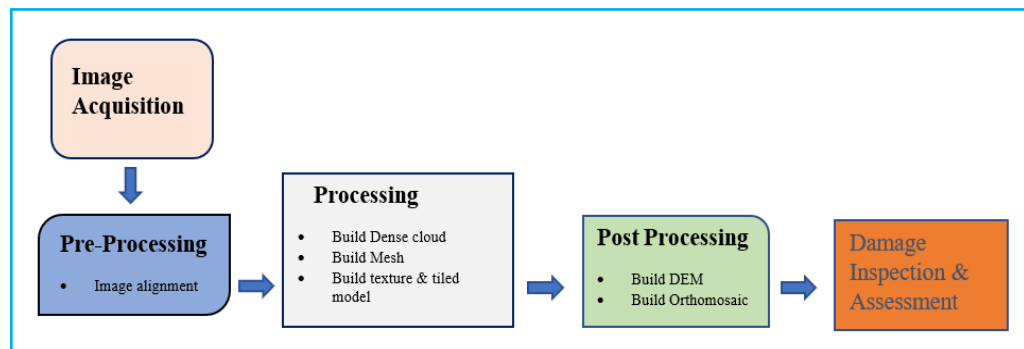
Figure 8. Workflow for 3D reconstruction

Advanced photogrammetry techniques were applied to process the collected imagery and generate a 3D point cloud of the bridge. DJI Terra software tools specialized in 3D reconstruction was used to create 3D models of the bridge. The workflow on the 3D reconstruction is further explained on Figure 8.

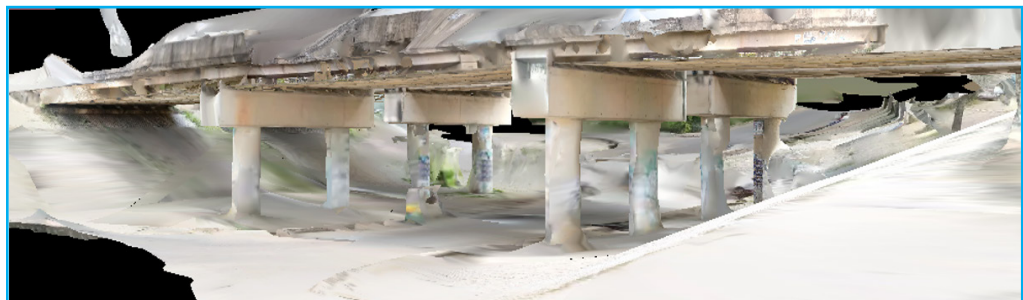
Figure 9. 3D model of the bridge generated by DJI Terra

Figure 9 and Figure 10 shows the 3D model which was used to visualize the bridge for the presence of damages like cracks, corrosion, delamination, concrete deterioration, etc. The identified damages include rebar exposure, algal delamination and deterioration caused by water as shown in Figure 11, Figure 12 and Figure 13 respectively.

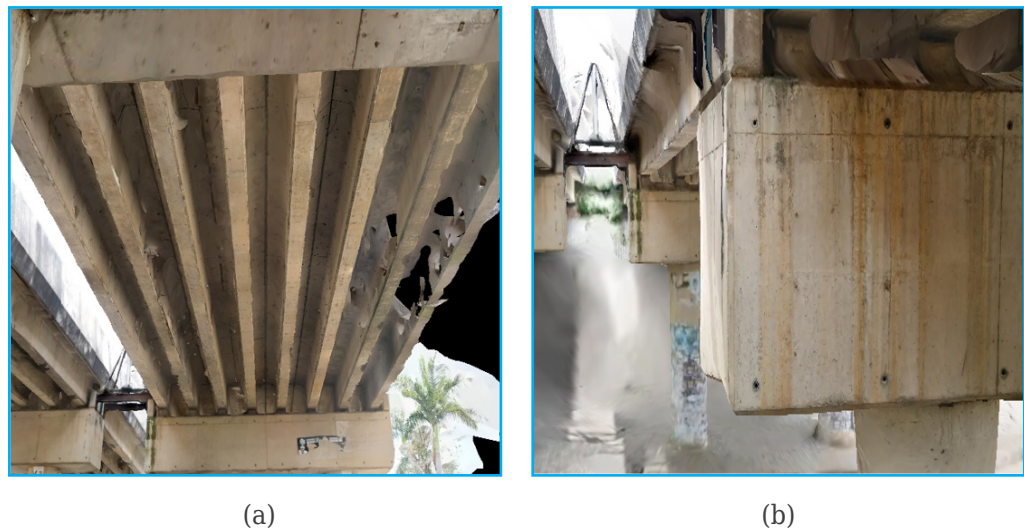
Figure 10. 3D model generated by DJI Terra

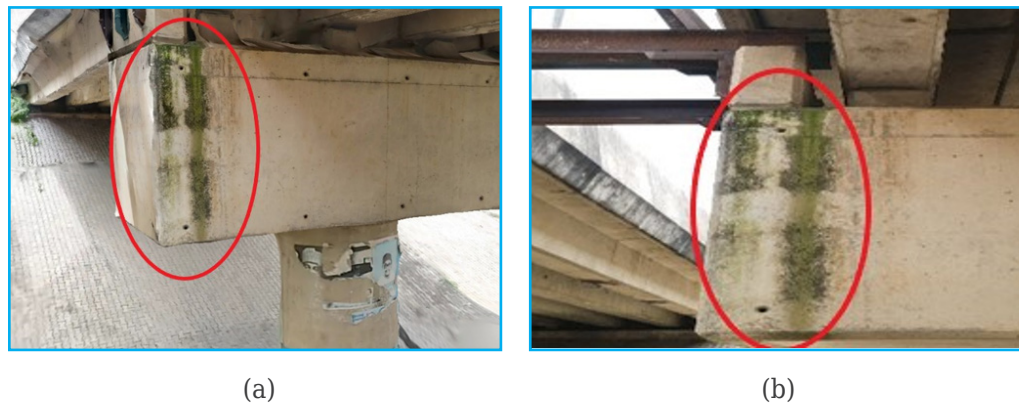
Figure 12. Identified damage due to algae: 3D reconstructed model (left) and the real image (right)

As shown in Figure 12, sections of the bridge's surface exhibited pronounced algae growth, particularly on the pier cap. This greenish discoloration was prevalent on horizontal surfaces and areas with reduced sunlight exposure. This damage was identified on the 3D model in 4 different locations at the substructure and may have a long-term effect on the structural integrity of the bridge. The damage is clearly visible on the 3D reconstructed model as seen in Figure 12 (a) which also shows that the automated 3D reconstructed model by DJI Terra is effective for computerized damage identification. Algae can accelerate the deterioration of concrete by promoting the growth of microorganisms and facilitating the penetration of water into the concrete matrix.

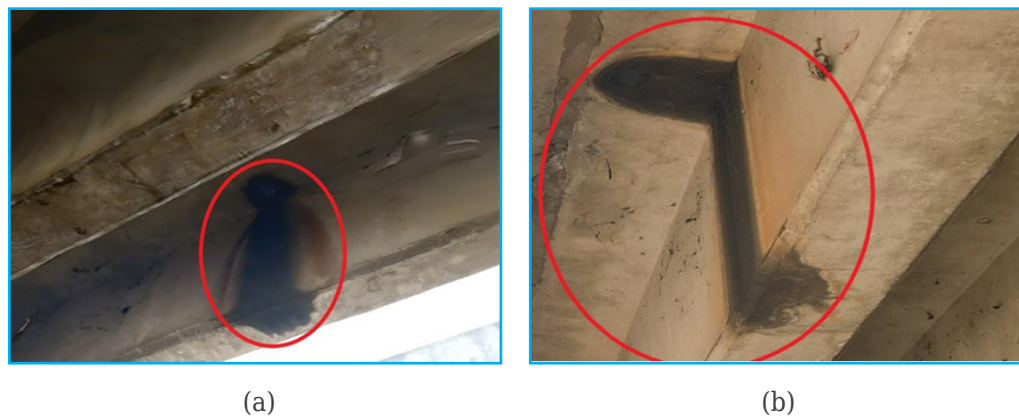
Figure 13. Identified deterioration caused by water: 3D reconstructed model (left) and the real image (right)

As shown in Figure 13, the 3D model revealed instances of surface deterioration attributable to prolonged water exposure. Noteworthy areas included the underside of the bridge deck and support structures directly in contact with water. Water-induced deterioration, if left unaddressed, may compromise the long-term durability of affected structures. This damage was identified on the 3D model in 18 different locations at the superstructure, particularly on the beam

girders and may have a long-term effect on the structural integrity of the bridge. This is as a result of water leakage through potholes on the bridge deck. Water ingress can lead to the corrosion of reinforcing steel, compromising the overall structural stability.

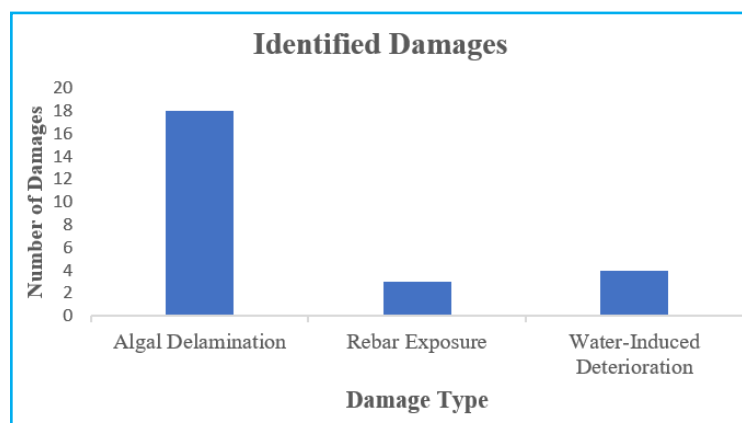
The model-based inspection performed satisfactorily; it enables the identification of damages that could have negative impacts towards structural safety. Table 4 shows the inspected damages which are identified in the 3D reconstructed model upon visualization. Table 5 shows the number, location and the structural effect of the identified damages on the model. Figure 14 shows bar chart extent of the identified damages on the 3D model.

Figure 14. Inspected damages
